Uniform Mitigation Verification Inspection Form

Inspection Date: 7/16/2020		
Owner Information		
Owner Name: Lake Clarke Gardens COA, Inc.		Contact Person:
Address: 2812 S. Garden Drive - Bldg #22		Home Phone: (561) 965-8487
City: Lake Worth	Zip: 33401	Work Phone:
County: Palm Beach		Cell Phone:
Insurance Company:		Policy #:
Year of Home: 1970	# of Stories: 3	Email: controller@lakeclarkegardens.com

Inspectors Initials BD **Property Address** 2812 S. Garden Drive - Bldg #22 Lake Worth, FL 33401 DMI: 1299969

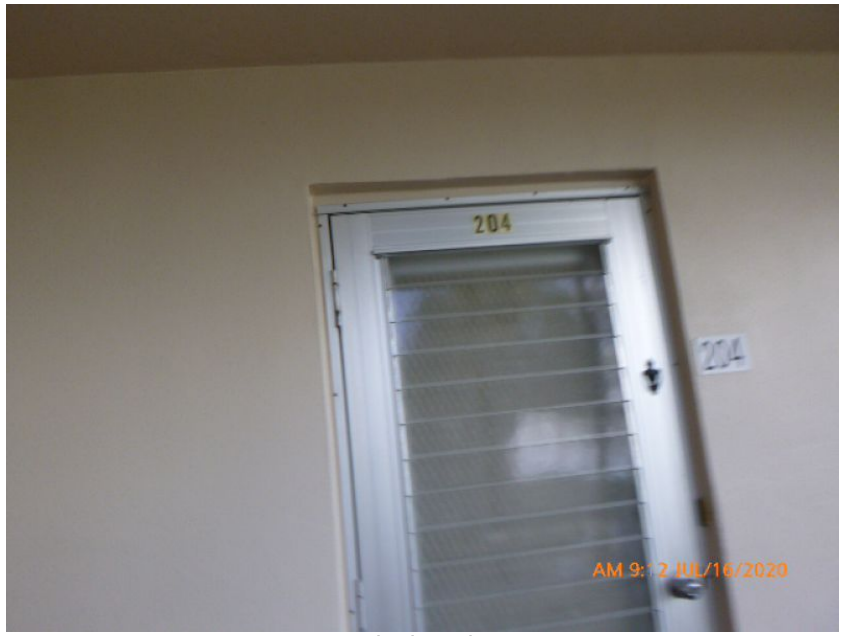
Unprotected Solid Entry Door
